# Manhole Inspection Summary

Manhole # S53E\_\_008MH

Insp Date: **4/29/08 8:22 AM**

**Location** Address: **3202 leverton ave**

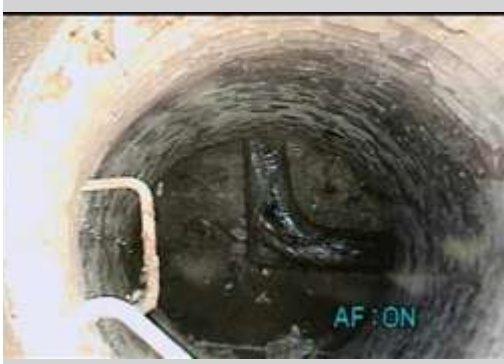
Defect 2

Condition: ☐ Sound ☐ Cracked ☐ Root Intrusion ☐ Deteriorated ☐ Leaks ☒ **Debris**

Bench Debris

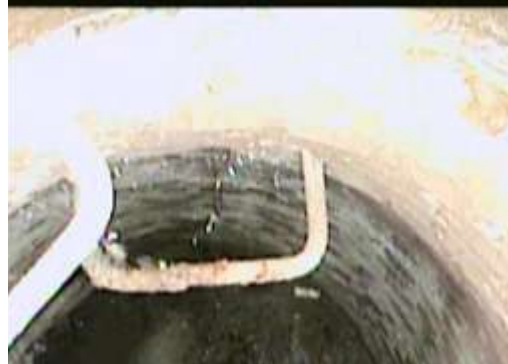
Defect 1

Count: **5** Missing: **2** ☒ **Corroded**

steps

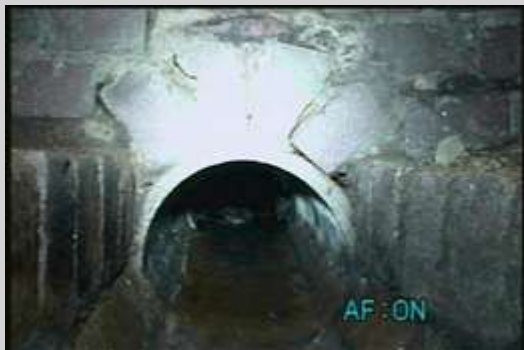
12 O'Clock Outflow

8 in. Circular Gravity Sewer  
Pipe Out @ 12 O'Clock

Invert Depth: **9.30** (ft.) Flow Characteristics: **Fast**

Deposits: ☒ None ☐ Mud ☐ Sludge ☐ Debris ☐ Grease

Infiltration: **None** Pipe Seal Cond: **Unknown**

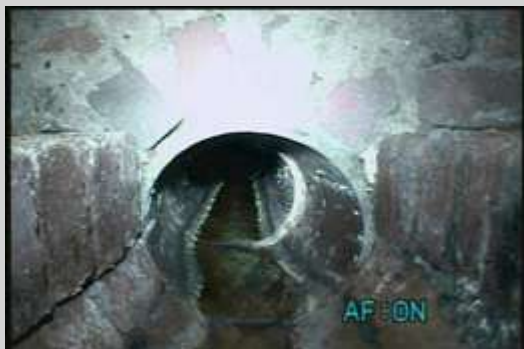
3 O'Clock Inflow

8 in. Circular Gravity Sewer  
Pipe In @ 3 O'Clock

Invert Depth: **9.10** (ft.) Flow Characteristics: **Fast**

Deposits: ☒ None ☐ Mud ☐ Sludge ☐ Debris ☐ Grease

Infiltration: **None** Pipe Seal Cond: **Unknown**
